Case History No.11 MOTOR DRIVE END BEARING FAILURE

P9801A & P9801B pumping units are responsible for the circulation of Santotherm 66 (a heating medium typically at an operating temperature of 296°C). Both machines form part of the C.I.M.A.H regulation 1984 (Control of Industrial Major Accidents Hazards) and are critical to the SHOP PU manufacturing process.

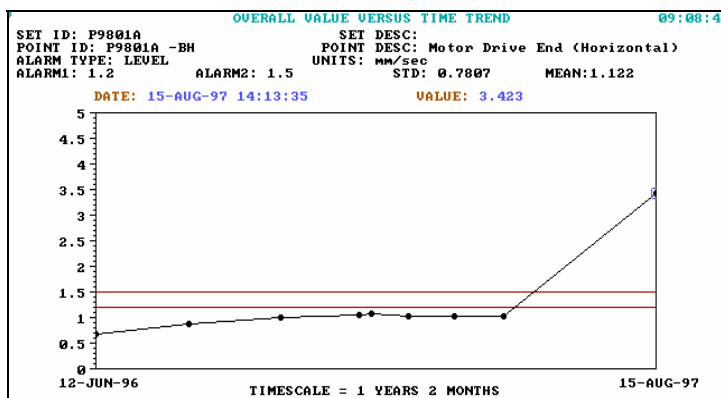
When the two machines were again service rotated some 4 months later a 'step change' in the overall vibration levels was observed at both the non drive end and drive end of the P9801A motor see Figure 1 below, the pump vibration levels remained unchanged. Vibration levels recorded at the motor drive end bearing were higher than the non drive end bearing thus indicating the source of the problem to be in this area, however the cause was not yet known.

Figure 1 - Step change in overall vibration

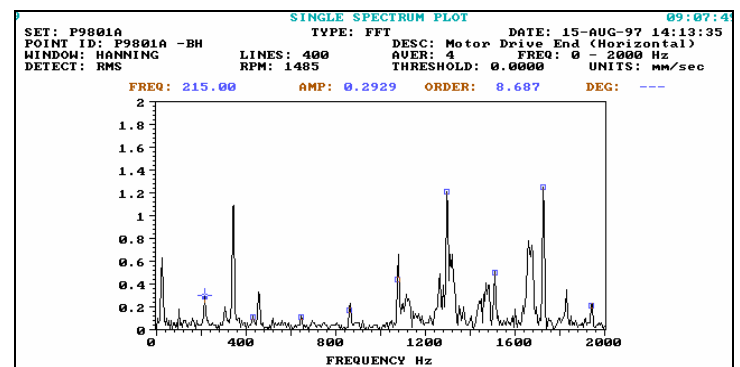
Analysis of the vibration spectrum indicated a large amount of spike energy along the 2kHz frequency range, from this information several fault types could be eliminated i.e. balance, alignment, coupling problems etc. The information

in the vibration spectrum initially pointed to a suspect drive end bearing, however, further analysis of the vibration spectrum would have to be carried out. Once the bearing fundamental defect frequencies had been determined I was able to link some of these frequency values to the frequency peaks evident in the vibration spectrum. In doing so, I identified a fundamental defect frequency of 215Hz strongly suggesting a fault on the outer race/roller of the single row roller bearing at the motor drive end, see Figure 2 below.

Figure 2 - Vibration spectrum indicating a bearing problem

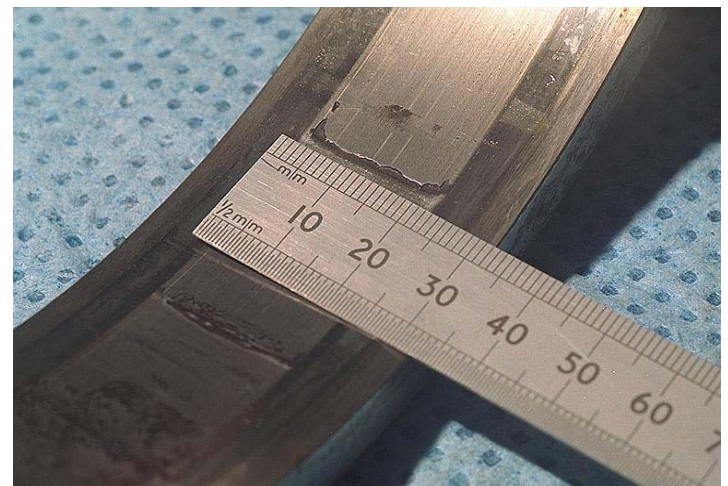
Examination of the original bearings proved the analysis to be correct as several areas of damage were evident on the roller bearing outer race, and also on the rollers themselves. The photograph below is clear evidence of this damage.

Figure 3 - Damage to roller bearing outer race
