Case History No.34 G441 Utility Shaft Pressurisation Fan Bearing Failures

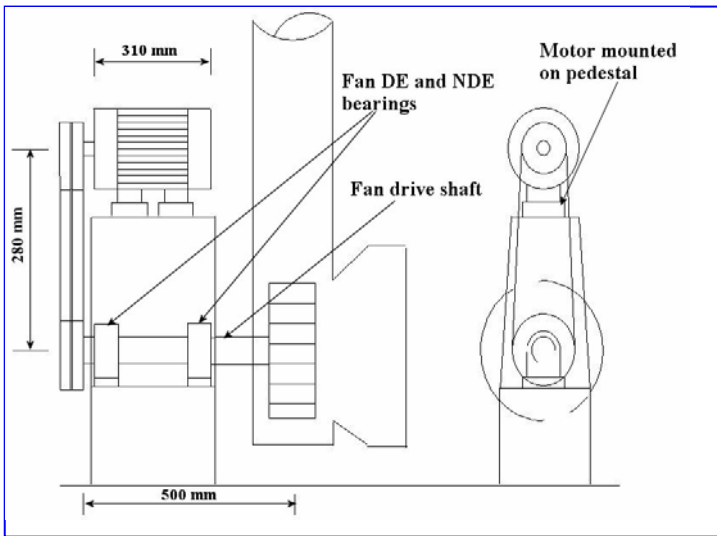
Figure 1 - Fan and motor layout

G441 Utility shaft pressurisation fan is one of two fans used to provide cooling air for six Sea Water Lift Pumps, situated on the 86m level in the Platforms Utility shaft. A drawing of the fan can be seen in figure 1.

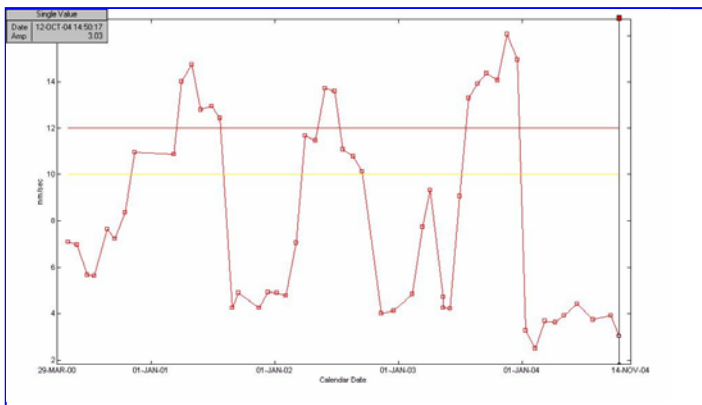
Figure 2 – Overall vibration at Fan DE H

Over a period of four years the mean time between failures was relatively short for G441, as can be seen in figure 1, whereas for G442 the failure rate was a lot less (figure 3).

Each time the overall vibration increased to an 'alarm level', the fan bearings and pulleys were replaced, reducing the overall level to within ISO 10816-1

recommendations. Within six months however the amplitudes would increase to outside the acceptable recommended levels.

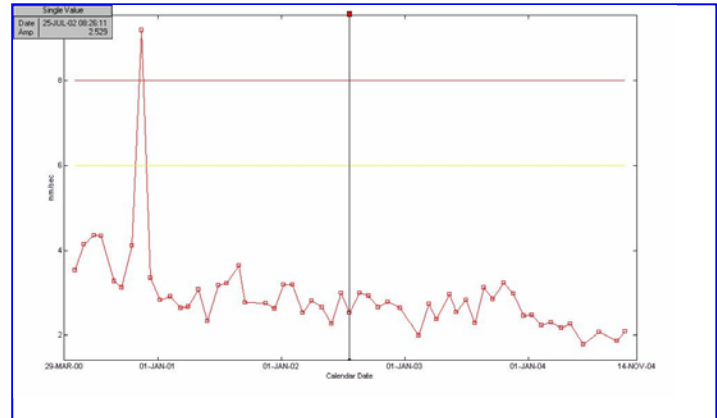
Figure 3 – Overall vibration at Fan DE H for G442

It was decided to investigate the root cause of failure for this fan, since there had been only one bearing failure on G442, in the same period of time.

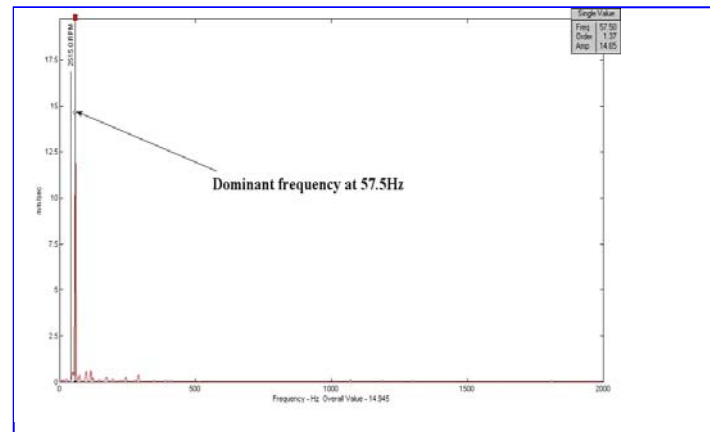
Figure 4 – Vibration Spectra of G441 at Fan DE Horizontal

Inspection of the vibration spectra on G441, identified the dominant component to be 1 x fan rpm, which was 57.5 Hz, as can be seen in fig. 4

The outside diameters of the pulley sheaves on both G441 and G442 were measured and compared. It was found that during maintenance on G441, the pulley sheaves had been reassembled the wrong way round, i.e. the motor pulley put on the fan and vice versa.

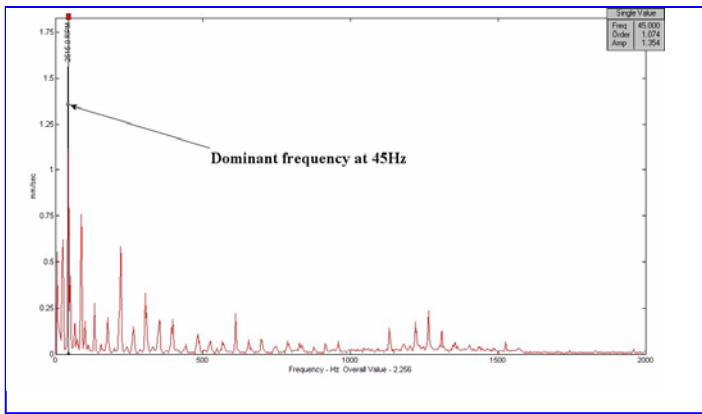
Figure 5 - Vibration Spectra of G442 at Fan DE Horizontal

Spectra taken on the same bearing on G442 showed the dominant component to be 1 x fan rpm, however the frequency on this fan was 43Hz, as shown in figure 5.

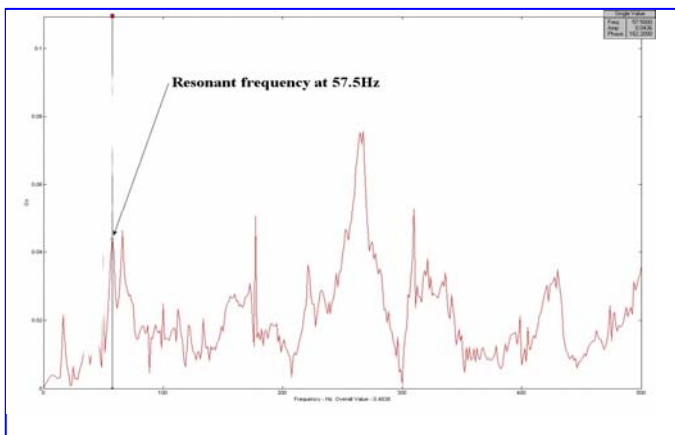
Figure 6 – Spectra from bump test on G441 Fan DE bearing

A bump (resonance) test was carried out on the fan drive shaft bearings of G441, in order to identify the resonant frequencies. Results from the bump test can be seen in figure 6.

The results showed that the fan bearings had a resonant frequency of 57.5 Hz, which was the running speed of G441's fan. An investigation into what should have been the correct fan speed showed that it was 45 Hz.

If the driver pulley diameter was 142mm and driven pulley diameter 123mm as it was, then the 1 x fan rpm

component equates to 57Hz, which coincides with the resonant frequency.

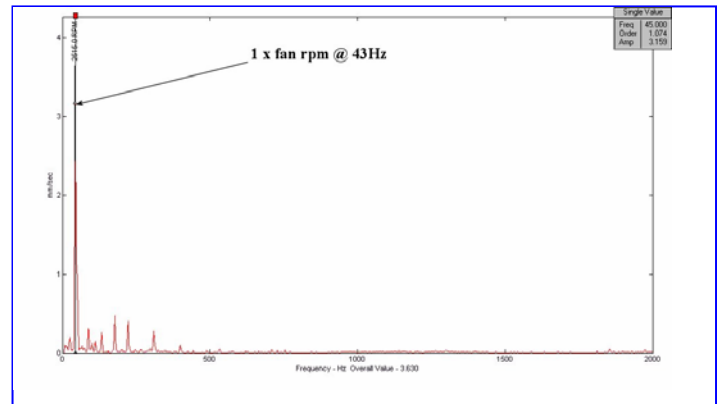
Figure 7 – Vibration Spectra of G441 at Fan DE Horizontal after reassembly

The vibration levels on G441 are now within ISO 10816-1 guidelines. Had it not been identified, the fan bearings for G441 would have continued to fail. Although the cost of replacing the bearings is relatively low, the first indication of a failure of these fans is when the Sea Water Lift Pumps begin to overheat. At this stage these pumps require shutting down, until both fans are available and their temperatures have reduced.

After the pulley sheaves were assembled correctly, vibration data was taken on the Fan DE bearing and the results can be seen in figure 7.
