## Case History No. 35 G3610A GLYCOL INJECTION PUMP GEAR COUPLING FAILURE

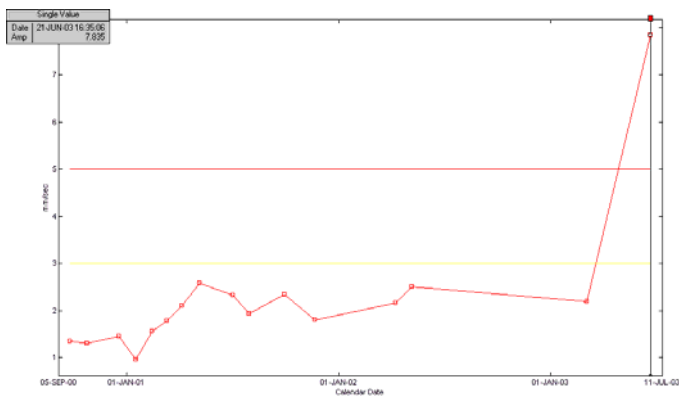
The trend plot shown in Figure 1 identifies a step change at the Pump NDE Vertical position, during the vibration survey conducted on 21 June 2003.

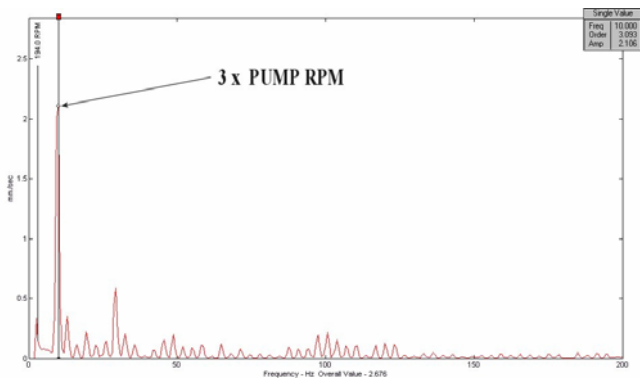
Figure 2

There are similar increases in both the axial planes on the pump and the axial plane on the gearbox DE output shaft. The spectrum plot in figure 2, shows that the dominant component is at 10Hz. The spectra taken from all the axial positions of the gearbox output shaft, had similar results.

10Hz equates to 3 x fundamental frequency, which is being generated by the 3 torque reactions, as each piston is being driven in the pump.

In the radial plane, the vertical vibration was much greater than the horizontal and combined with high axial vibration, indicates probable misalignment had developed across the output shaft coupling.

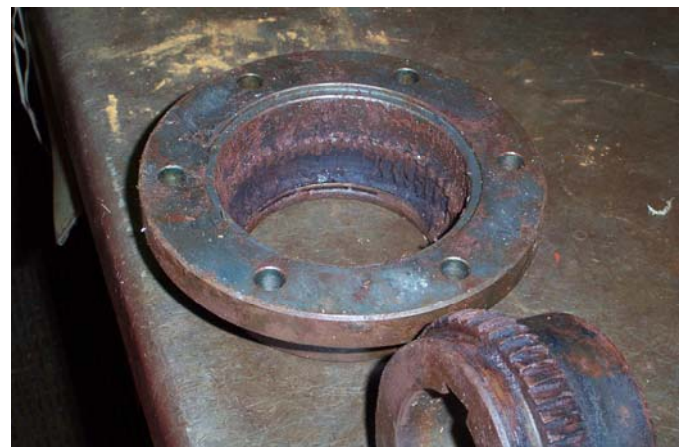
Figure 4

It could be seen that some of the internal gear teeth on the sleeve had disintegrated and that there was damage to the flexible hubs outer teeth, as shown in figure 4.

This prevented any angular or axial movement in the coupling, causing high axial and radial forces to be transmitted as vibration.

The coupling, the gearbox DE bearing and both the pump DE & NDE bearings were replaced.

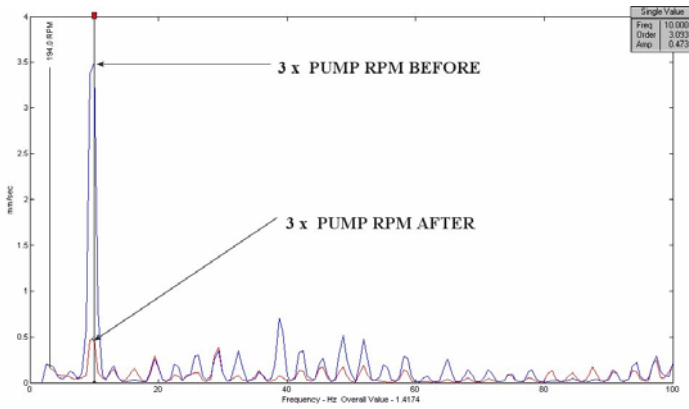
Figure 5

Figure 3 shows the spectra taken at the pump DE axial position before and after the coupling was replaced.

The vibration levels are now at an acceptable level of 1.72 mm/sec, having been 7.84 mm/sec prior to the coupling change.
