## Case History No.5 K9451 COUPLING IMBALANCE

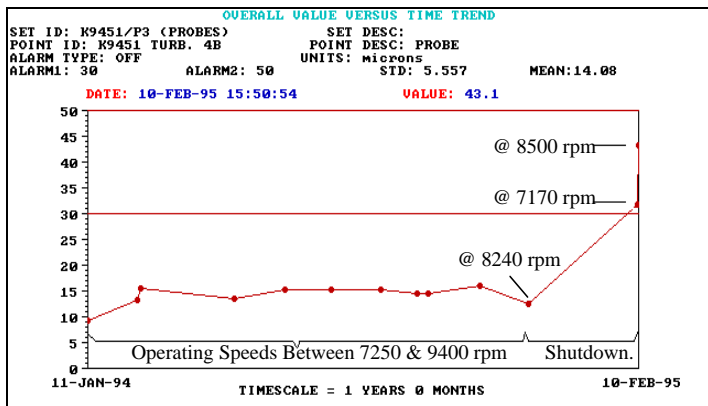
Historical data recorded on our on site database revealed that vibration levels prior to the process unit shut down were normal for all bearing cap readings and also the Bently Nevada displacement probe data. Bearing cap readings that day were typically below 2mm/sec rms and gave no cause for concern. However, during start-up with the machine running at 7170 rpm, the Bently Nevada probes indicated the highest overall shaft vibration relative to the bearings of about 32 microns. When the running speed was increased to 8500 rpm the highest overall shaft displacement increased to over 43 microns see Figure 1 below.

Figure 1 - Trend plot indicating overall vibration level changes

Examination of the vibration spectrum exhibited a dominant component at the running speed frequency with an amplitude of 38 microns pk-pk indicating a probable imbalance condition of the turbine rotating element. Further questioning revealed that a new rotating element had been fitted to the turbine during the January 1995 shutdown, strongly suggesting the turbine as the source of vibration, as levels on the compressor exhibited little change from previous tests. To confirm this, the turbine was uncoupled from the compressor and run up to 7250 rpm with the coupling boss still in place. The running speed component was now less than 10 microns, clearly the turbine rotor itself was not at fault and attention switched to the coupling. As this was the same coupling that was producing under 15 microns prior to the shutdown, suspicion turned to the build

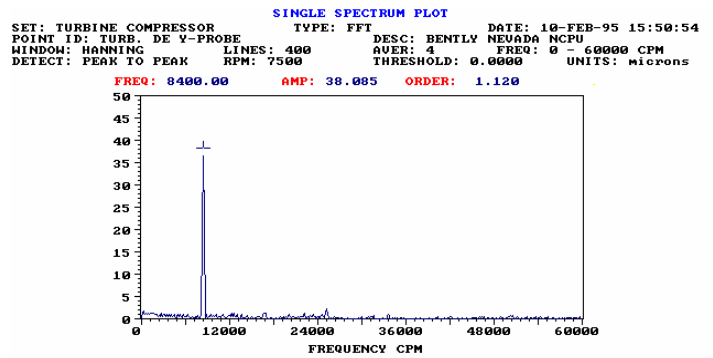
up of the coupling and its associated packing pieces/shims. During inspection of the coupling it was noticed that the spacers between the coupling bosses and the spool piece had been fitted in a different configuration to that prior to shutdown. The coupling was re-fitted according to all the match-marks and the coupled unit was run up to 9000 rpm. Highest reading of around 10 microns clearly indicated that the source of the imbalance had been correctly located and rectified. See Figures 2 and 3 below (before and after)

Figure 2 - Before coupling correction

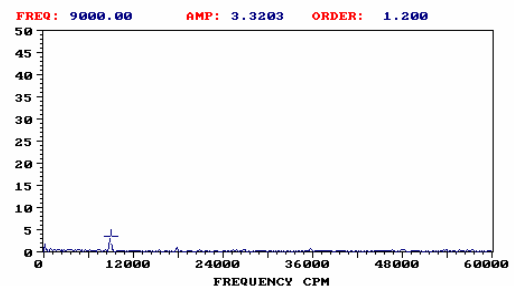
Figure 3 - After coupling correction
