Case History No.7 HIGH SPEED PUMP COUPLING IN-SITU BALANCE CORRECTION

P2152B is an electric motor driven boiler feed water pump coupled to a 2 shaft gearbox designed to increase the speed from 2970 rpm (input), up to 5400 rpm (output).

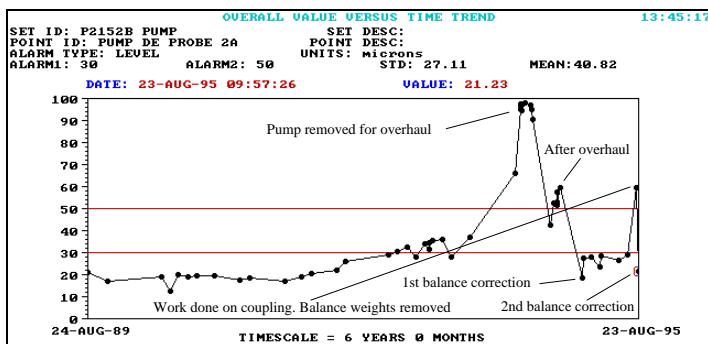
From December 92, and up to April 94 the displacement readings taken from the pump drive end bearing were becoming erratic, and had reached an overall level of 65 microns pk-pk, indicating a possible problem with the pump or coupling unit.

In May 94 the overall vibration level had reached 95 microns pk-pk, the pump was removed from service and sent for overhaul and balance check/correction, see Figure 1 below.

Figure 1 - Overall displacement trends at pump drive end

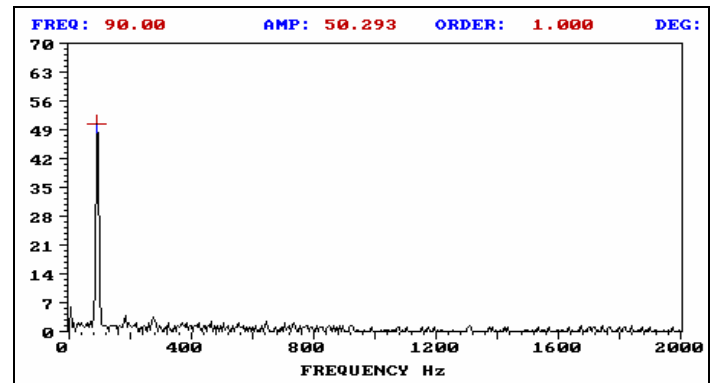
On examination of the coupling, it was noted that the original correction weights had not been replaced and therefore required the balance correction to be performed again. Figures 2 and 3 below testify the before and after results.

Figure 2 - Imbalance before correction (50 μm pk-pk)

After a series of test runs, and with the addition of trail weights, we were able to calculate the correction weight and determine its angular position. From then on, the machine ran for some 7 months at levels below 30 microns, until such a time when the coupling was disturbed for maintenance purposes. After this work had been completed, vibration readings indicated that the initial imbalance had returned and thus the coupling was immediately suspect.

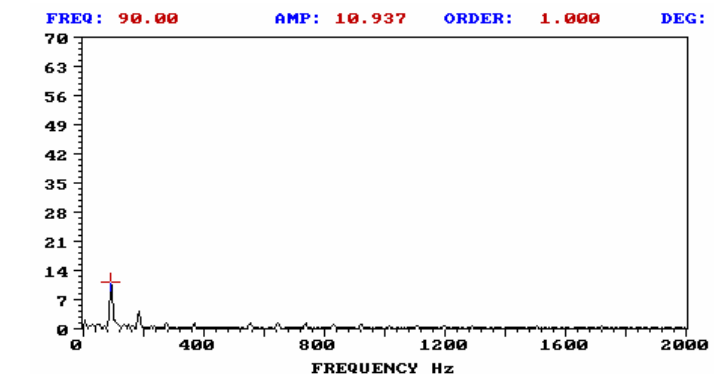
Figure 3 - Imbalance after correction (11 μm pk-pk)
