Case History No.8 VIBRATION ANALYSIS TO DETECT GEAR DAMAGE

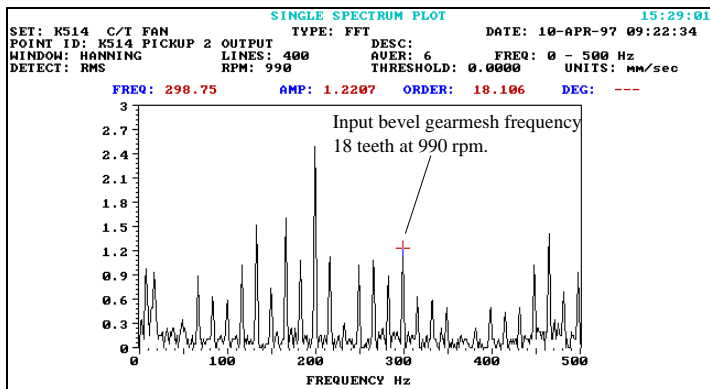
Figure 1 - Vibration spectrum indicating gear damage

From the above spectrum, and knowing the fan was running at low speed, we could identify the input bevel gear meshing frequency. Harmonic activities at the input shaft frequency of 16.5 Hz are evident at either side of the input gear mesh frequency. From this information, and technical data from the gearbox (Figure 2) it was concluded that the input bevel gear had sustained some degree of gear tooth damage.

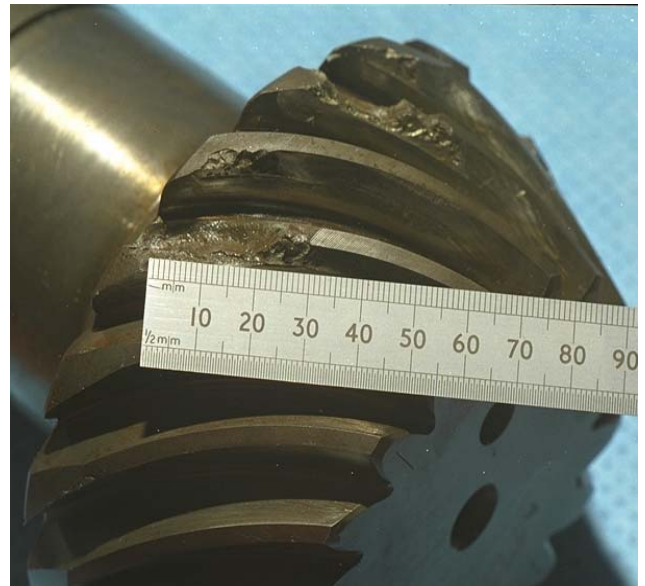
Figure 3 - Damaged input bevel gear teeth

Examination of the gearbox proved the analysis to be accurate, with damage to several of the bevel gear teeth evident. Figure 3 below is photographic evidence of the damaged gear teeth.

It is estimated that a saving of **£4,500** was made due to early fault detection, however, had this unit catastrophically failed then secondary damage could have run into *many THOUSANDS* of pounds more as the potential for damage to blades and structure is high.
