Case History No.9 IN-SITU BALANCE OF AN OVERHUNG FAN

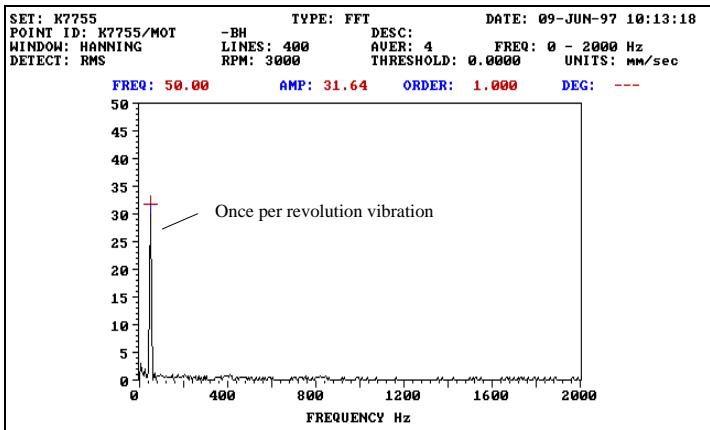
This case history shows how in-situ balance correction can be performed without the need of a costly machine outage. Vibration data collected from the motor of an overhung fan assembly indicated the worst recorded once per revolution vibration to be at the motor drive end horizontal direction with an amplitude of 30 mm/s rms as shown in Figure 1.

Figure 1 - High once per revolution vibration

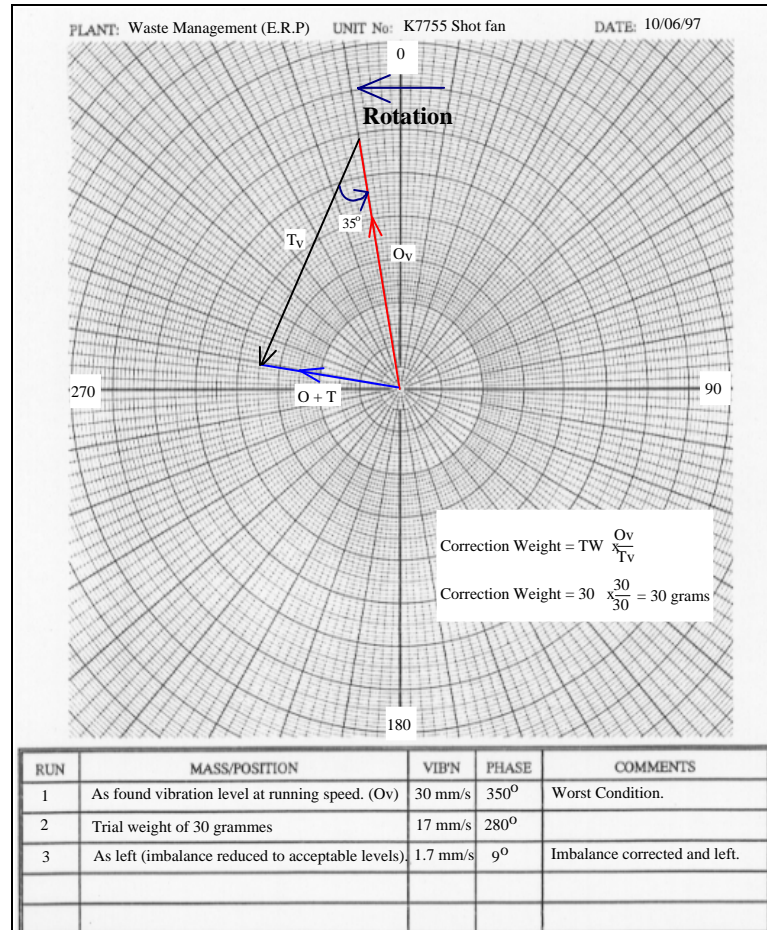
The amplitude of the once per revolution vibration, along with its angular position from a known reference, was plotted on a vector chart as 'O_v'. The machine was brought to rest and a mass of 30 grams added to the outer radius of the fan at an arbitrary position. The machine was brought up to speed and the new amplitude and phase angle of the once per revolution vibration plotted on the vector chart as 'O+T'. From these two vectors we could determine the vector change caused by the trial weight, this was plotted on the vector chart as 'T_v'. From these values the mass of the correction weight was calculated and its angular position from the trial weight found, see Figure 2.

Figure 2 - Vector chart indicating vibration levels and phase

The correction weight required was 30 grams and would have to be positioned 35° from the trial weight position in the direction of the machines rotation. Once the correction weight was fitted, the trial weight was removed and the machine run up to full speed.

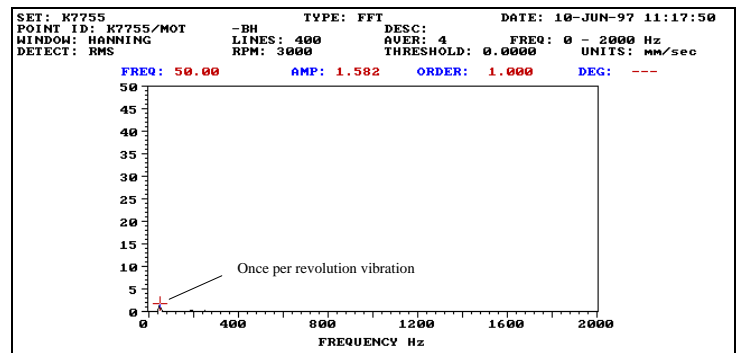
Vibration data recorded indicated that the source of the imbalance had been correctly located and corrected as depicted in Figure 3.

Figure 3 - Imbalance reduced to 1.6 mm/s rms
