## Case History No. 35 G3610A GLYCOL INJECTION PUMP GEAR COUPLING FAILURE

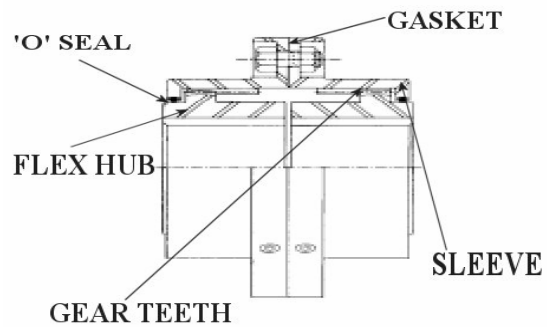
Figure 3

The coupling between the gearbox and pump is a gear coupling, as shown in Figure 3.

The gear teeth allow for any axial movement and angular offset, as well as transmitting torque; they also have a certain amount of backlash, allowing for lubrication. If there is no lubrication, these couplings can become locked and will develop high axial and radial forces.
