Case History No.8 VIBRATION ANALYSIS TO DETECT GEAR DAMAGE

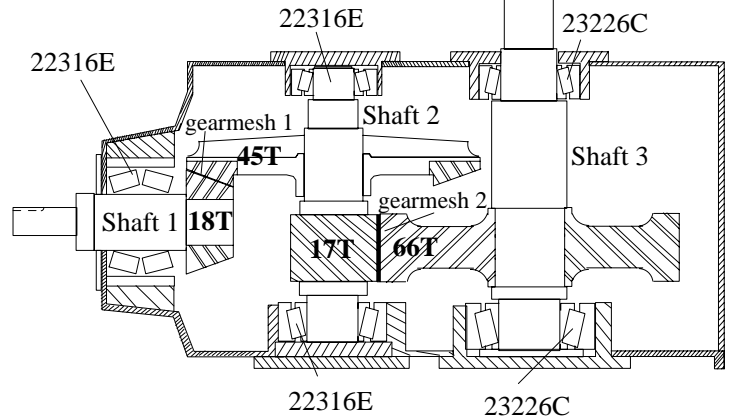
Figure 2 - Layout of gearbox internals

From the above spectrum, and knowing the fan was running at low speed, we could identify the input bevel gear meshing frequency. Harmonic activities at the input shaft frequency of 16.5 Hz are evident at either side of the input gear mesh frequency. From this information, and technical data from the gearbox (Figure 2) it was concluded that the input bevel gear had sustained some degree of gear tooth damage.

High Input Speed = 1485 rpm
Low Input Speed = 990 rpm
Gearbox Reduction = 9.7:1
